Manhole Inspection Summary

Manhole # S21K1_014MH

Insp Date: **4/24/08 9:41 AM**

Location Address: **2621 stranden rd**

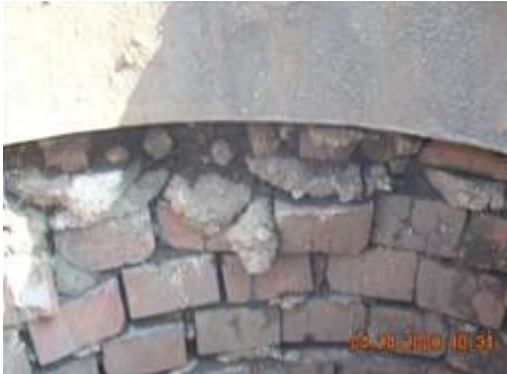
Defect 2

Condition: ☐ Sound ☐ Cracked ☐ Root Intrusion ☐ Loose Brick ☒ **Deteriorated**

deteriorated chimney

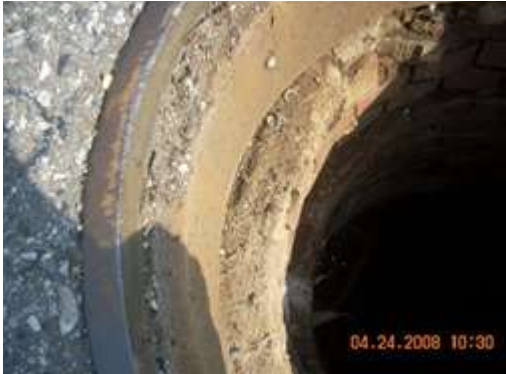
Defect 1

Offset: **2** (in.)

frame offset

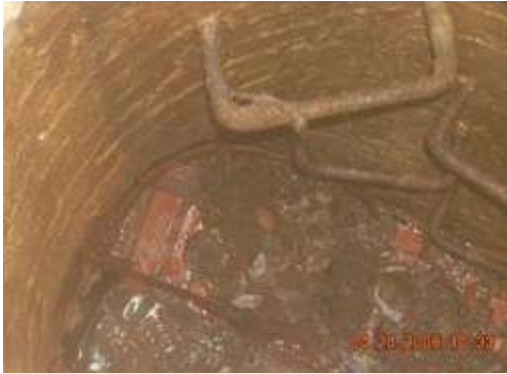
Defect 7

Condition: ☐ Sound ☐ Cracked ☐ Root Intrusion ☐ Deteriorated ☐ Leaks ☒ **Debris**

debris on bench

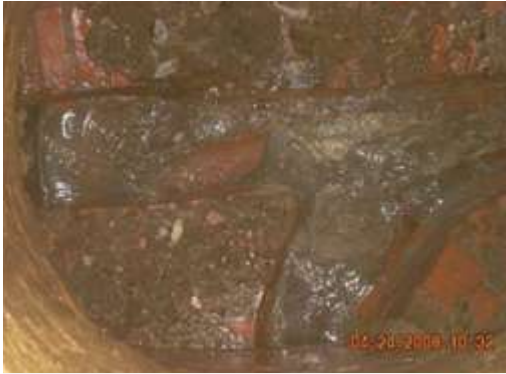
Defect 6

Condition: ☐ Sound ☐ Cracked ☐ Root Intrusion ☐ Deteriorated ☐ Leaks ☒ **Debris**

debris in channel

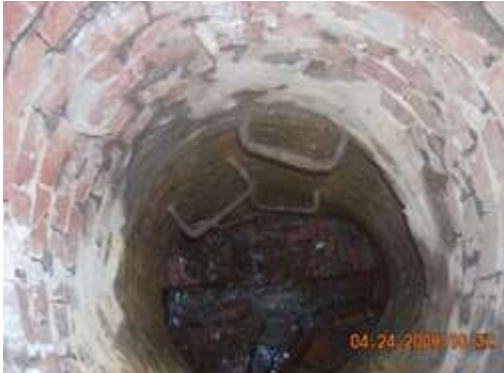
Defect 5

Count: **5** Missing: **1** ☒ **Corroded**

corroded and missing steps

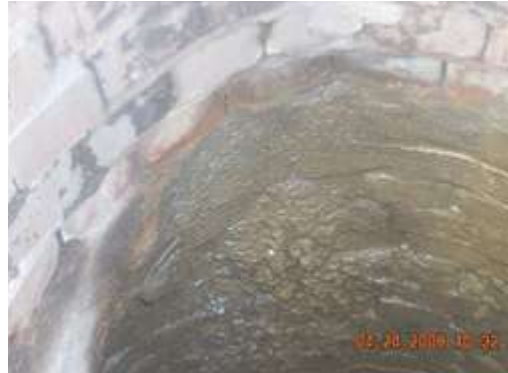
Defect 4

Infiltration: ☐ None ☐ Joint ☐ Cracks ☐ Mortar ☐ Roots ☒ **Wall**

infiltration @ corbel wall

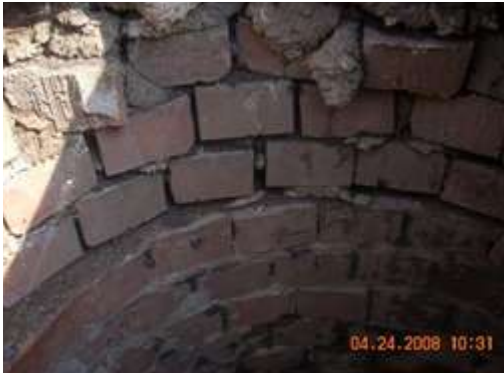
Defect 3

Condition: ☐ Sound ☐ Cracked ☐ Root Intrusion ☒ **Loose Brick** ☐ Deteriorated

loose corbel bricks

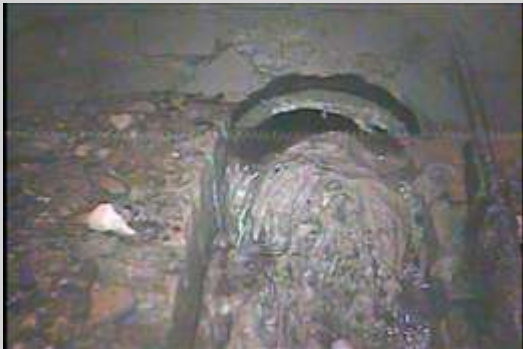
6 O'Clock Inflow

Pipe Height: **8.4** (in.) Rod and Bar (Angled)
Pipe Material: **Clay** ☐ Pipe Lined
Invert Depth: **11.11** (ft.) Flow Characteristics: **Slow**
Deposits: ☐ None ☐ Mud ☒ **Sludge** ☒ **Debris** ☐ Grease
Silt Depth: **7** (in.) Deposits Extent: **Heavy**
Infiltration: **None** Pipe Seal Cond: **Sound**
